TS-PIC-20202335S
May 2002

AERIAL PHOTOGRAPHIC ANALYSIS OF STANDARD CHLORINE CHEMICAL CORPORATION SITE Kearny, New Jersey

AERIAL PHOTOGRAPHIC ANALYSIS OF
STANDARD CHLORINE CHEMICAL CORPORATION SITE

Kearny, New Jersey

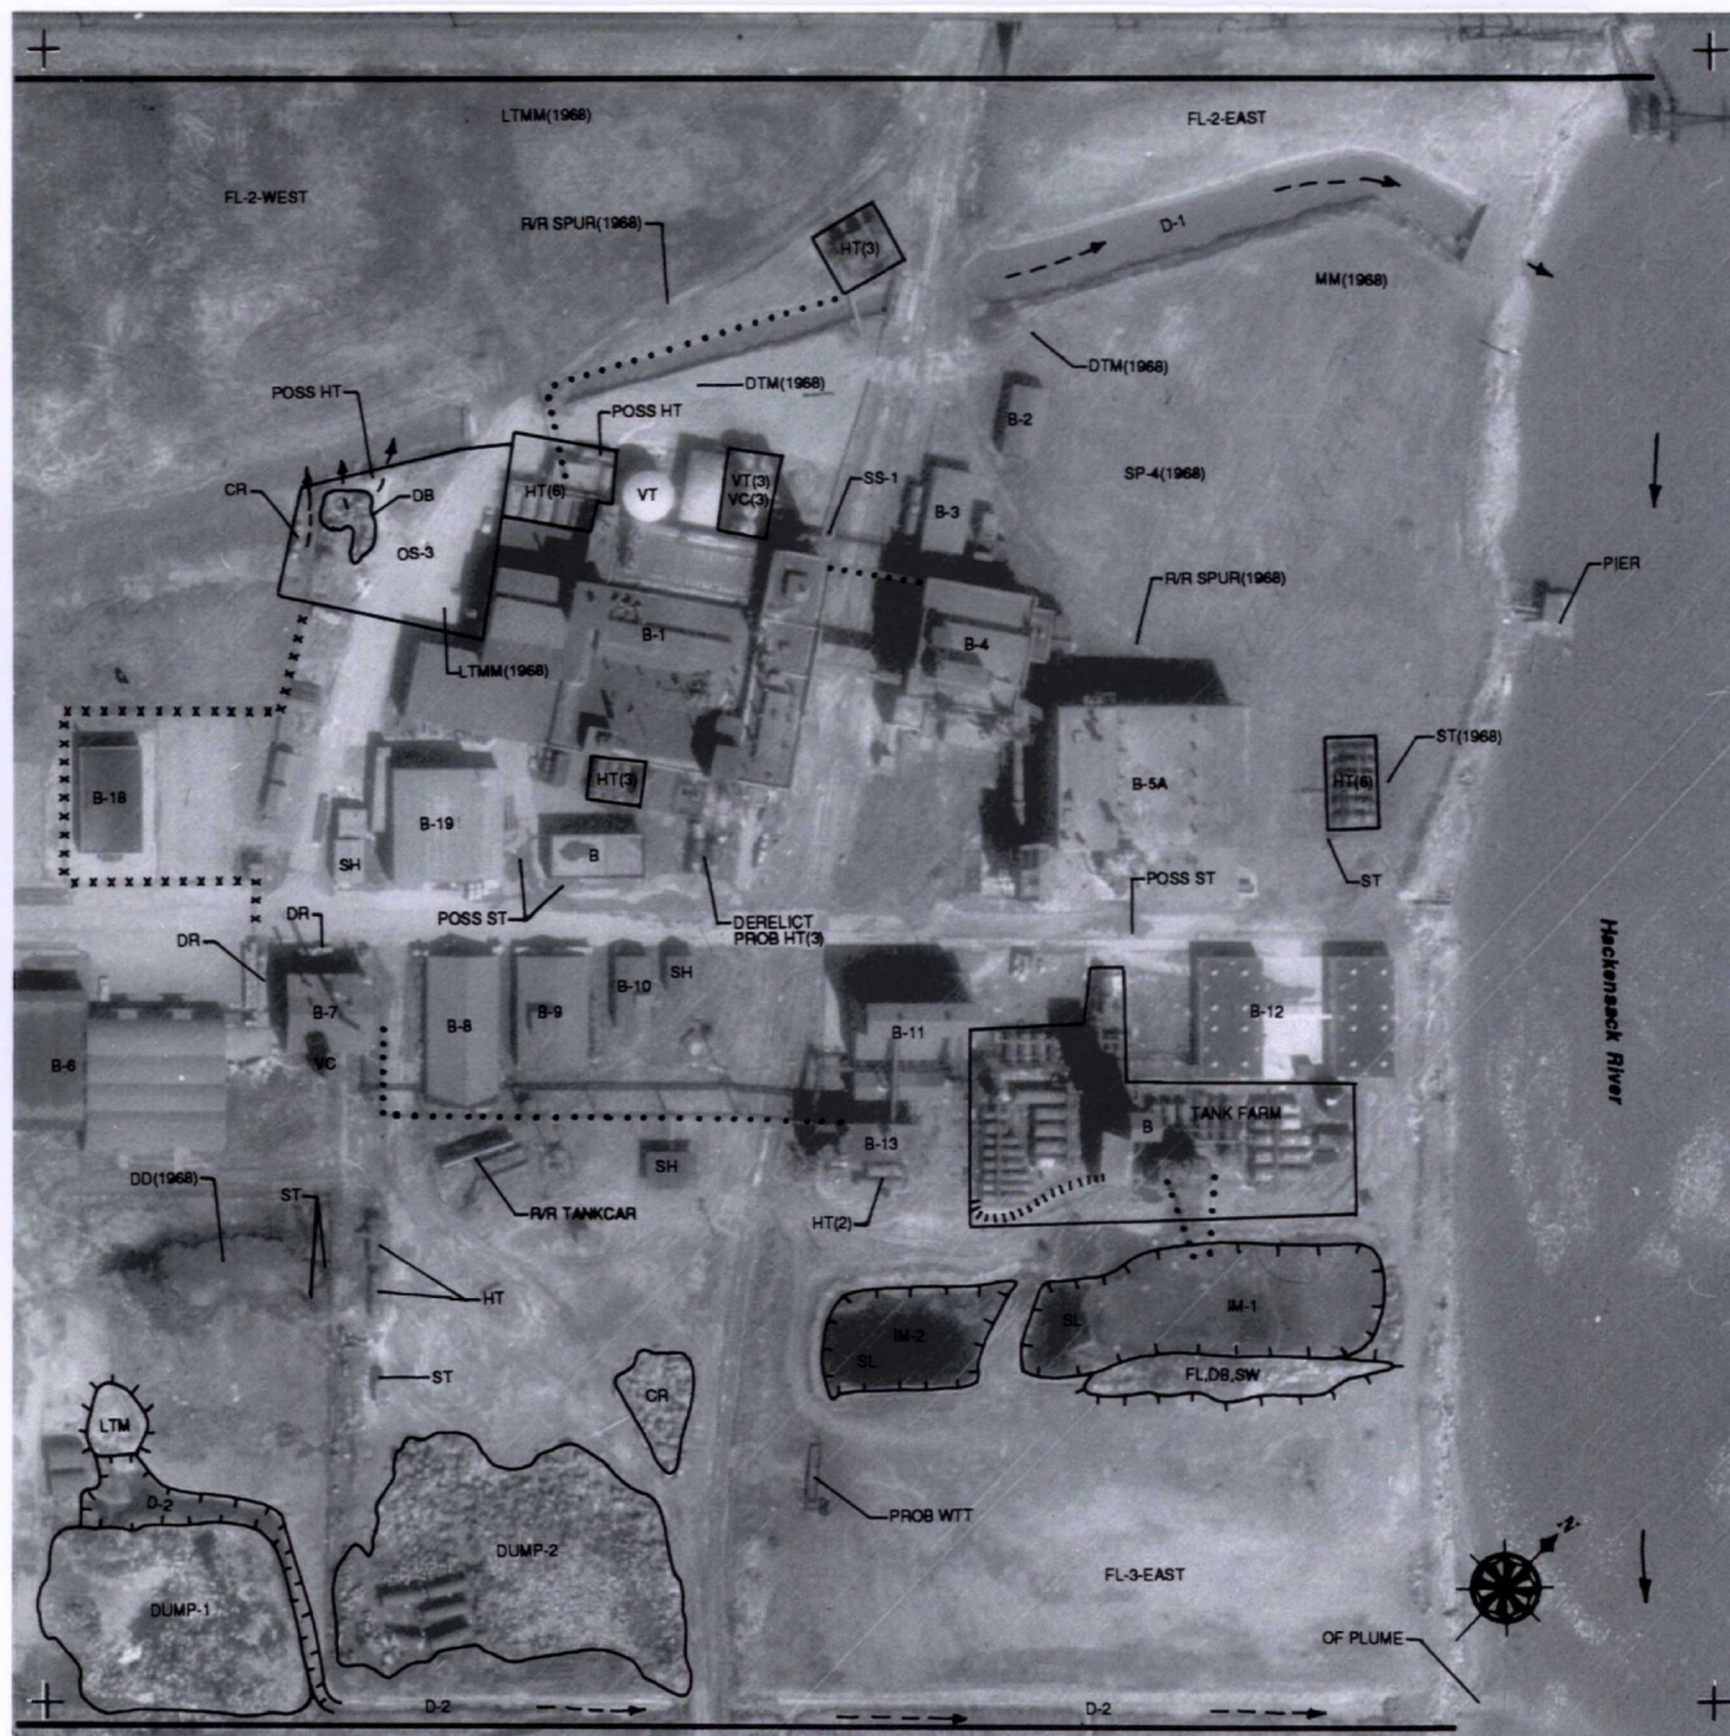
Figure 16. Standard Chlorine site, April 16, 1973. Approximate scale 1:1,650.

The open dumps Dump-1 and Dump-2 south of buildings B-6 and B-8 continue to increase in size with more accumulated possible debris and mixed light- and dark-toned material.

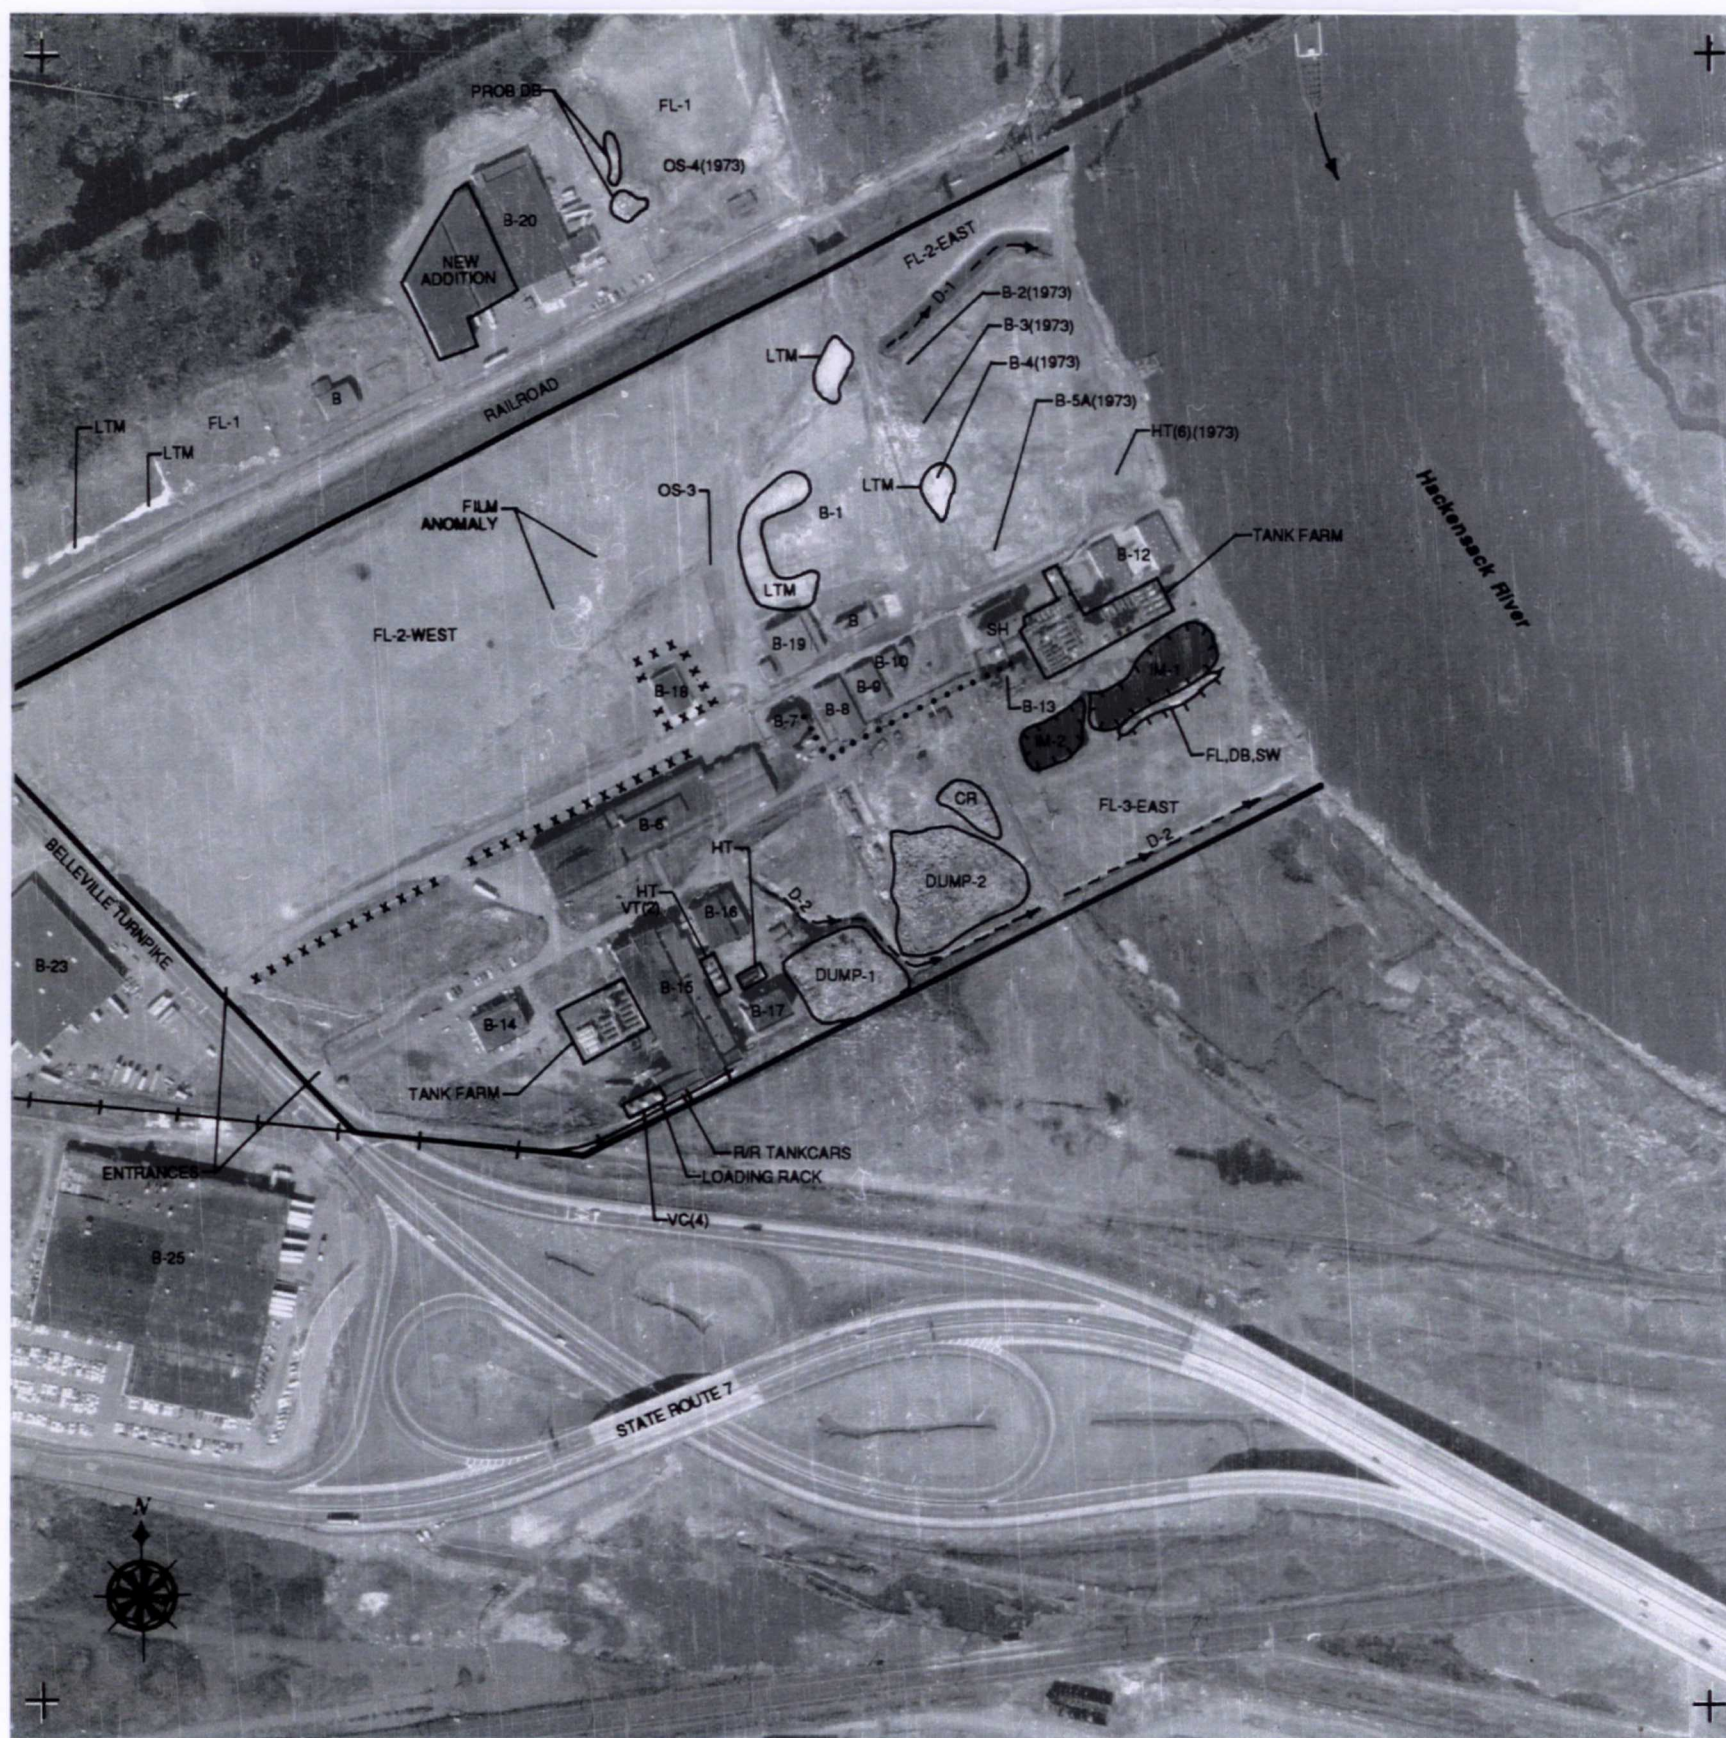
Storage area OS-5 on the east side of building B-15 is vacant. The open dumps Dump-1 and Dump-2 east of building B-17 continue to contain mixed light- and dark-toned mounded material, probable debris, probable crates/boxes, and possible solid waste (not annotated). Drainage ditch D-2 receives possible discharges and runoff from the southern portion of the site.

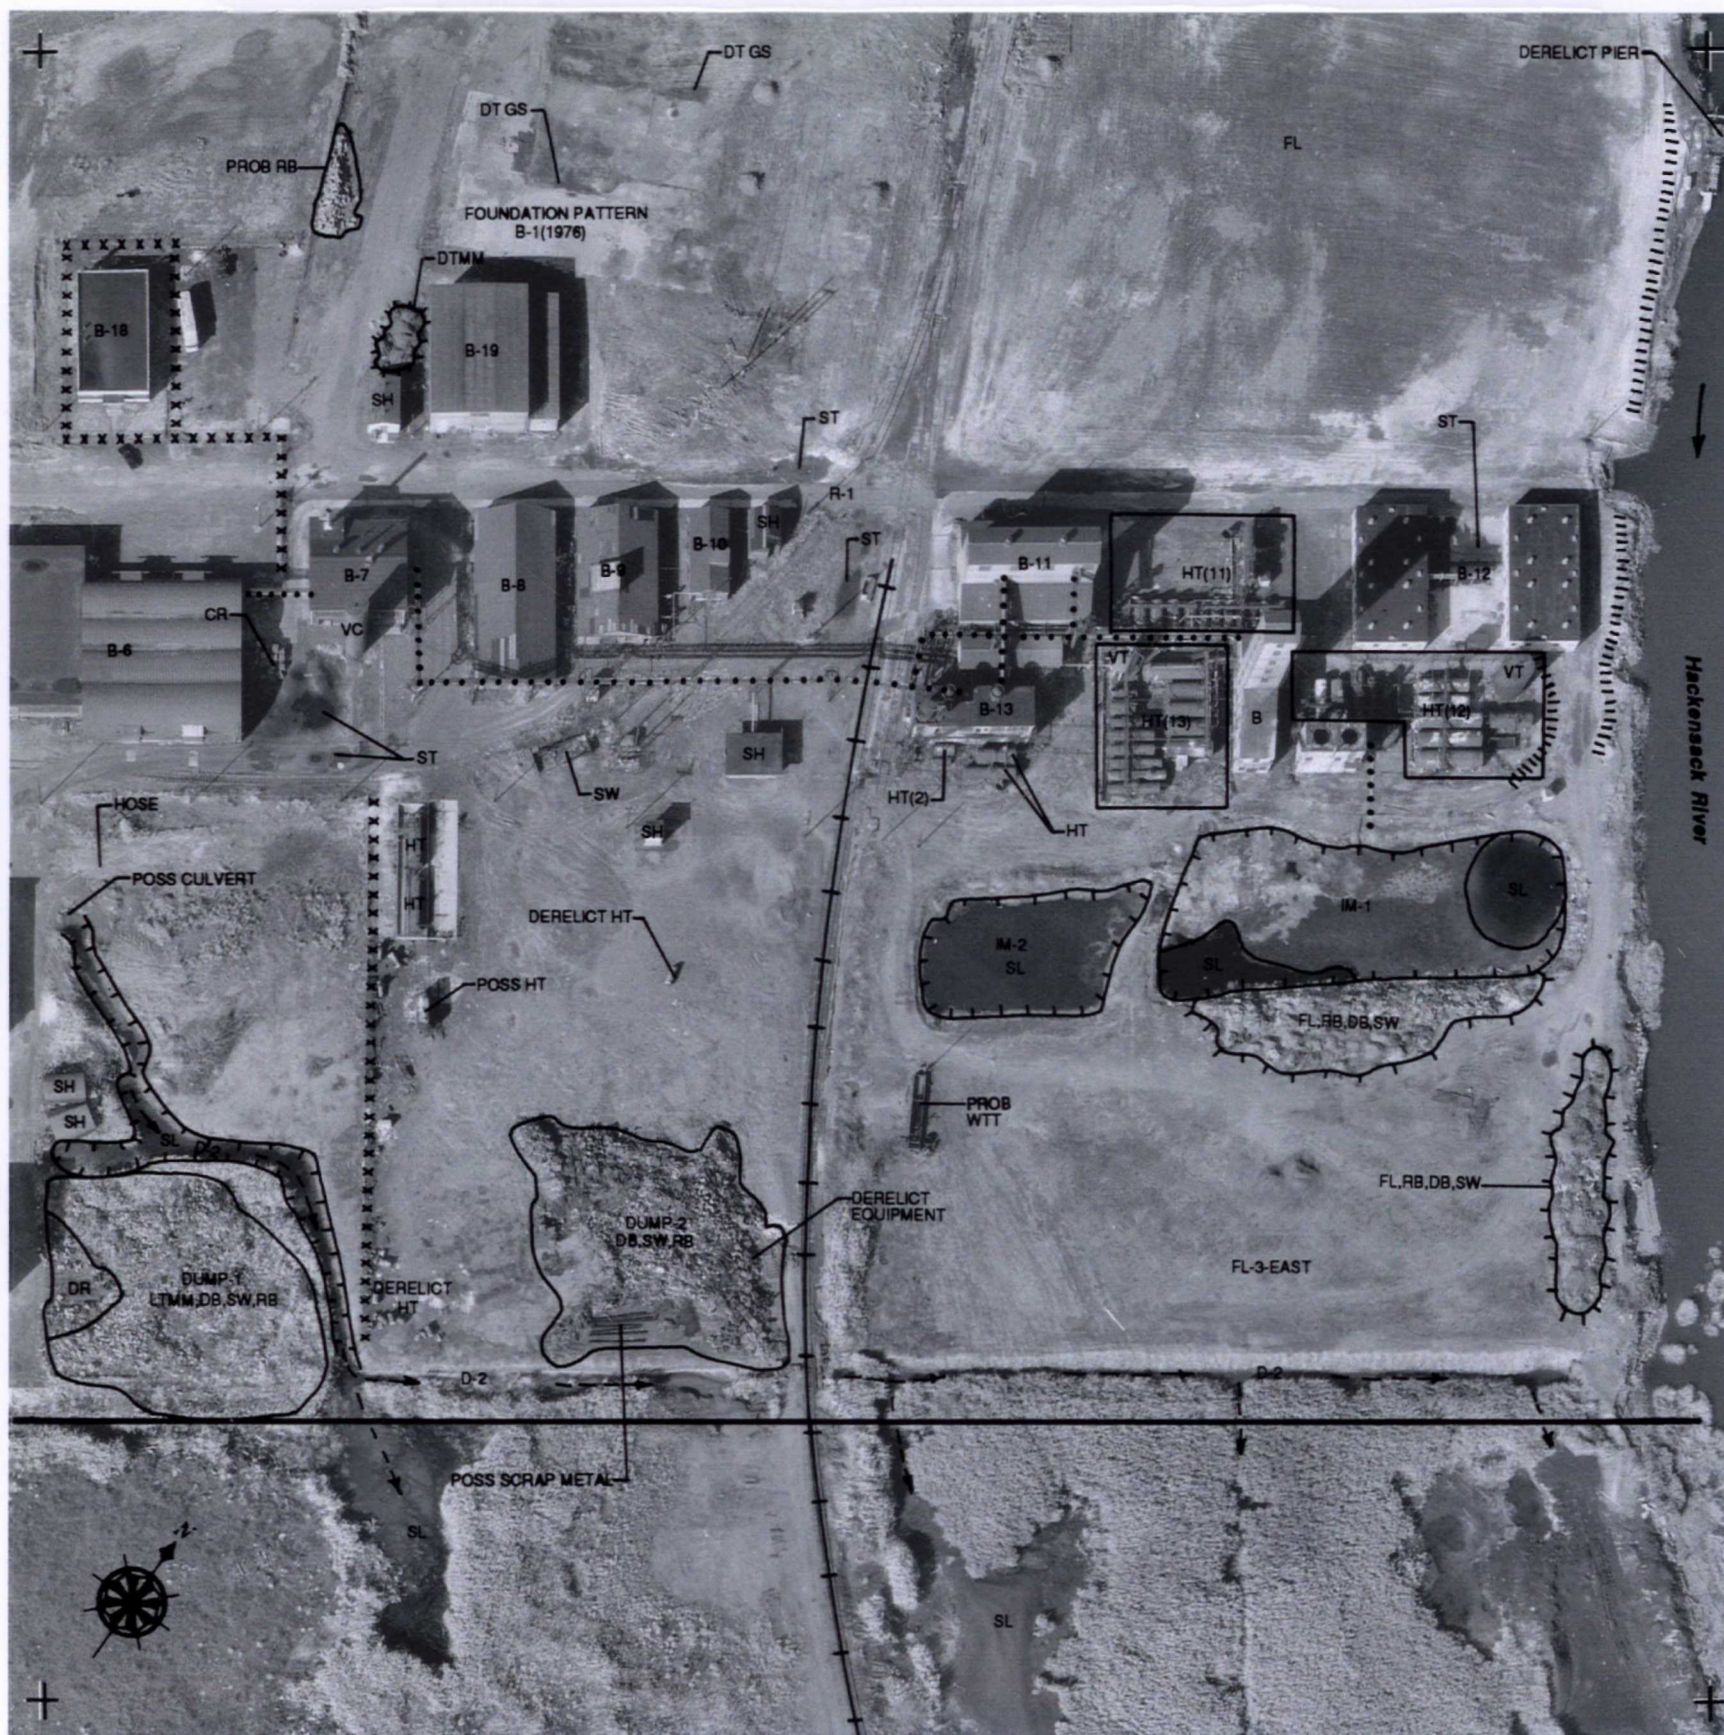
Figure 20. Standard Chlorine site, November 8, 1982. Approximate scale 1:1,440.

Ditch D-2 continues to receives possible discharges from Buildings B-15 through B-17 and runoff from the southern portion of the site. Ditch D-2 has deteriorated and runoff now enters a marsh area southeast of building B-17.

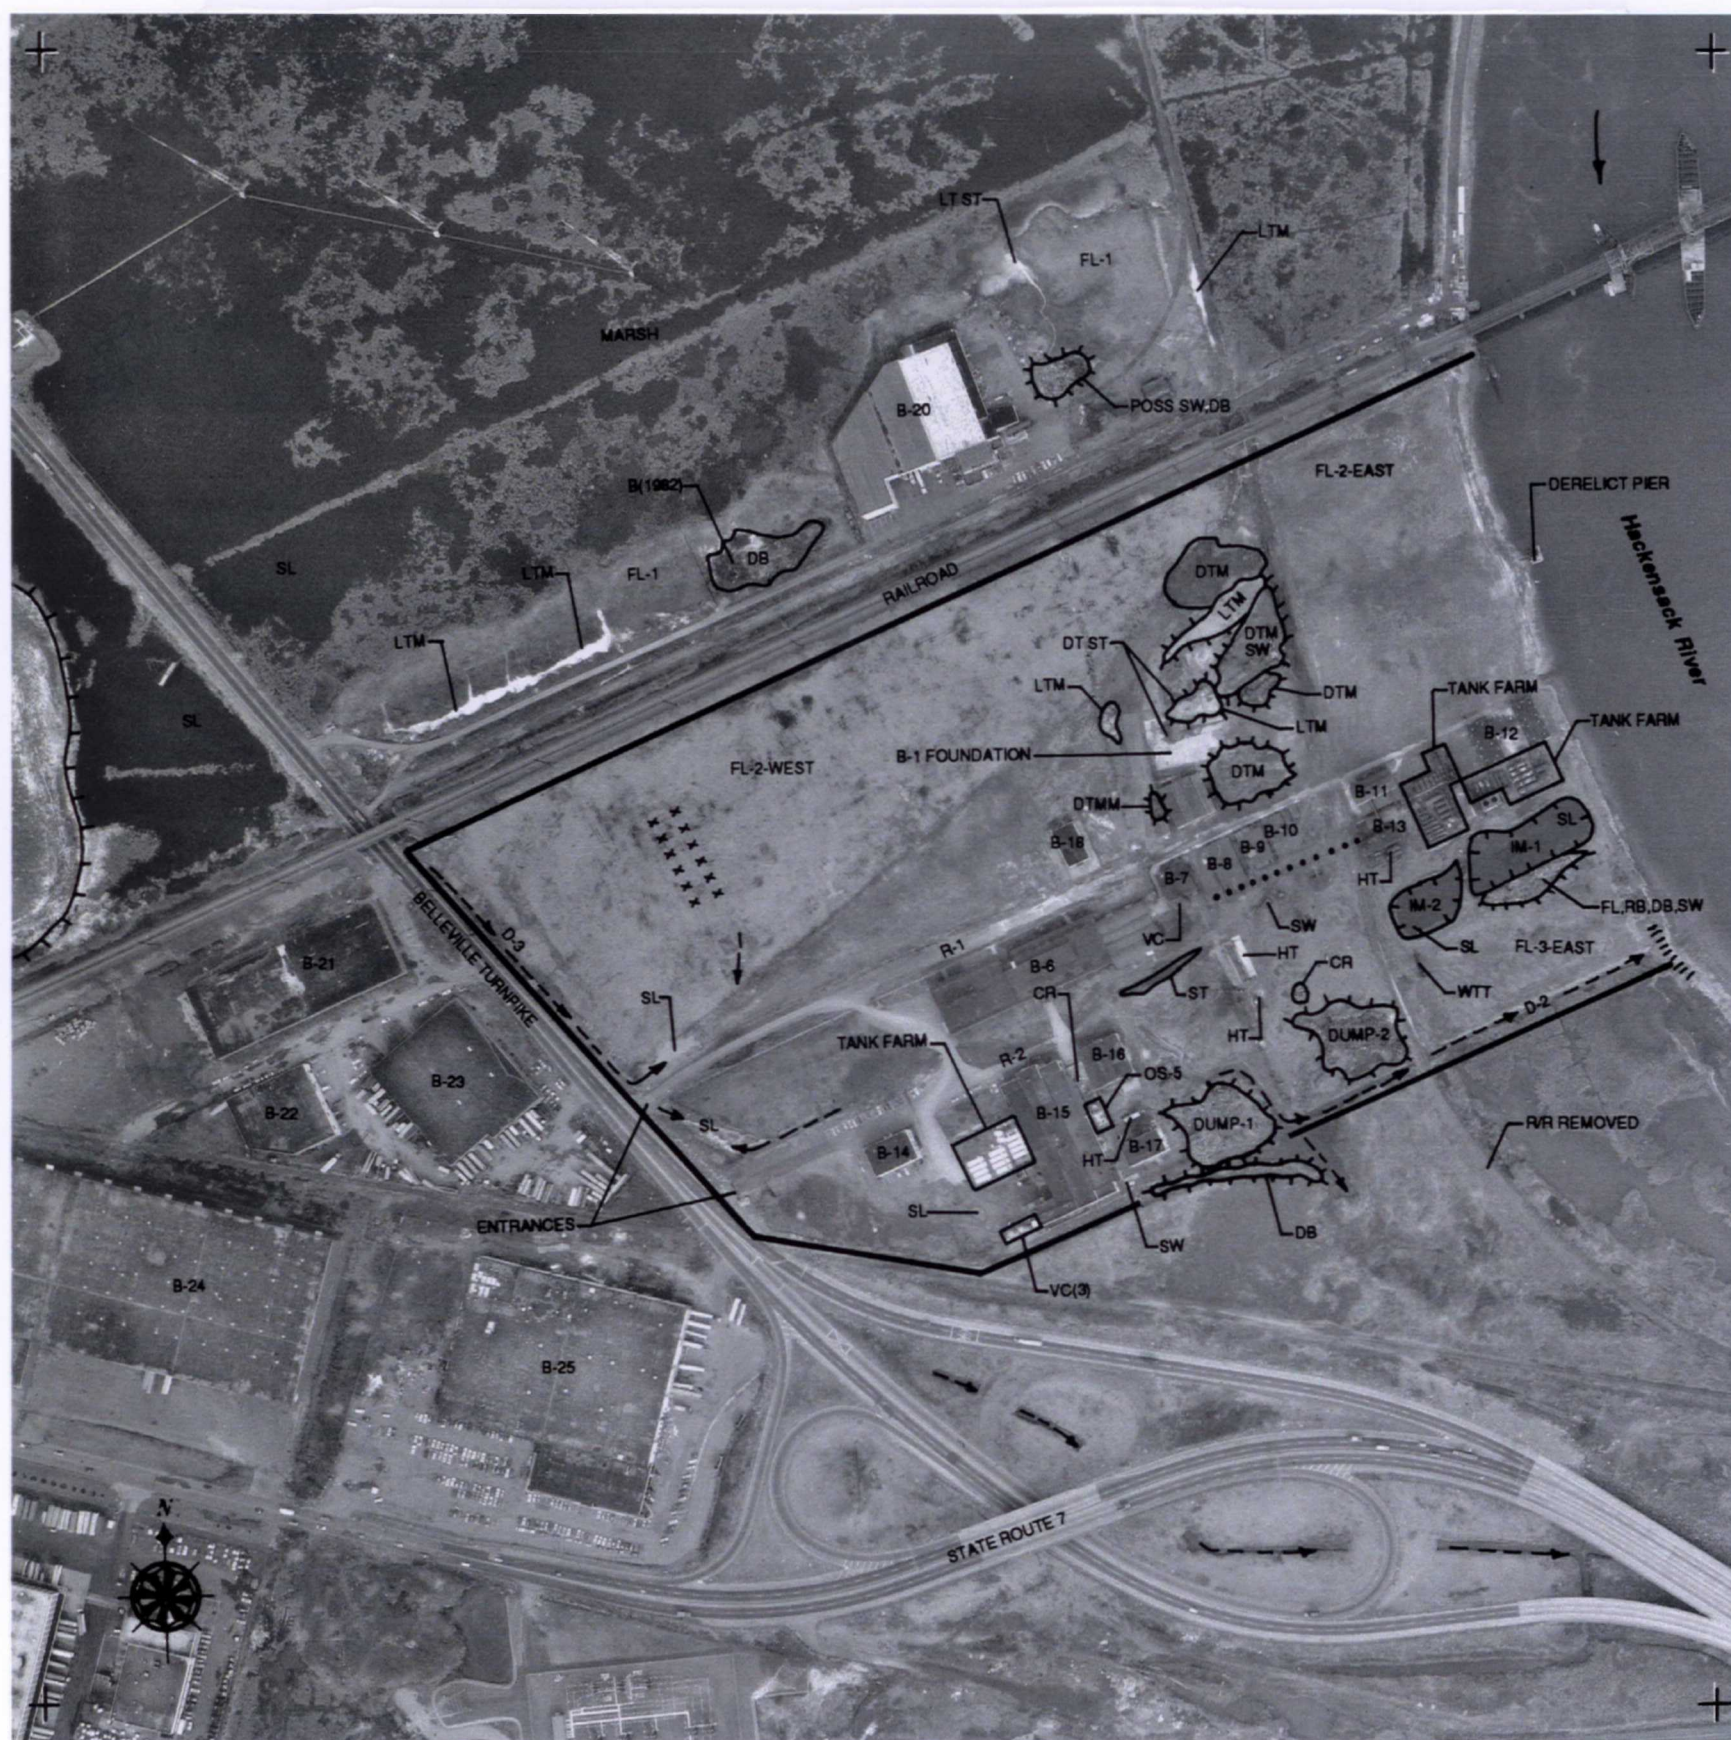
Buildings B-14 through B-17 appear to remain operational. No spillage or leakage is discerned at the tank farm on the west side of building B-15. One of the four vertical columns on the south side of building B-15 has been removed. A solid waste container is visible near the southeast corner of building B-15. Both open dumps Dump-1 and Dump-2 to the east of building B-17 remain, and do not appear to have changed significantly. An additional elongated mound of debris has been built up south of Dump-1.

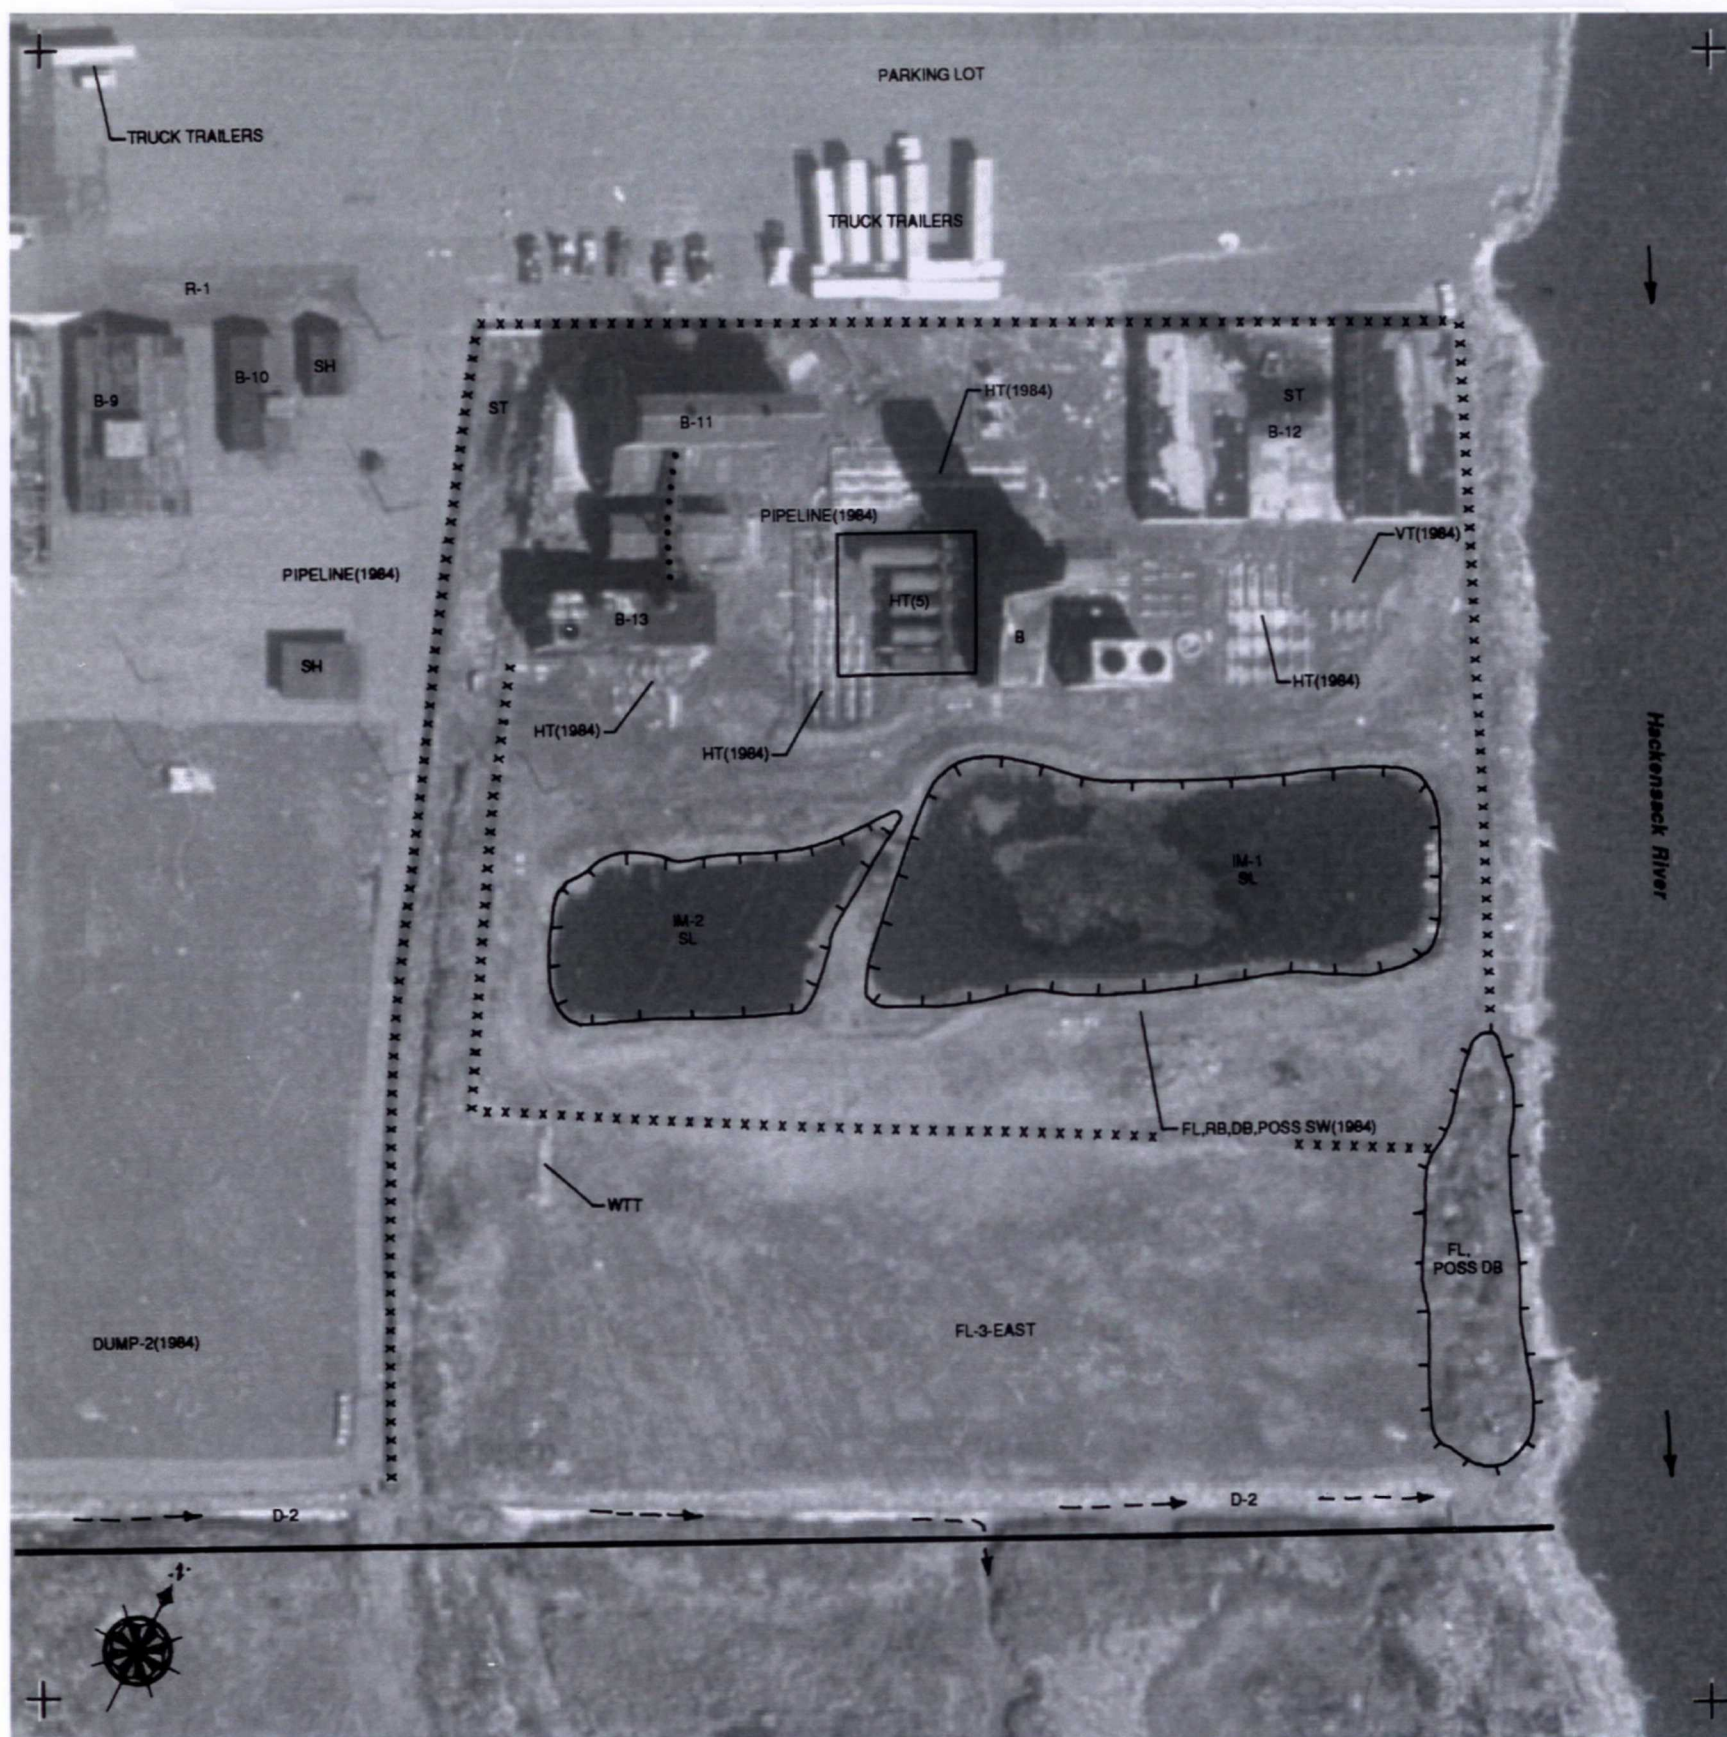
Both impoundments IM-1 and IM-2 remain but appear to be abandoned; dark-toned standing liquid is visible in each impoundment. Since 1984 a fence has been erected around the buildings and both impoundments. A bottom-lining material was not discerned in either impoundment at any time during this analysis. The fill, rubble, debris, and possible solid waste is no longer evident at the south edge of impoundment IM-1; however, fill and possible debris is again visible along the river bank south of impoundment IM-1.
